DULVERTON

CONSERVATION AREA APPRAISAL

Prepared for Exmoor National Park by John Fisher BA MA MRTPI IHBC

Published by Exmoor National Park Authority

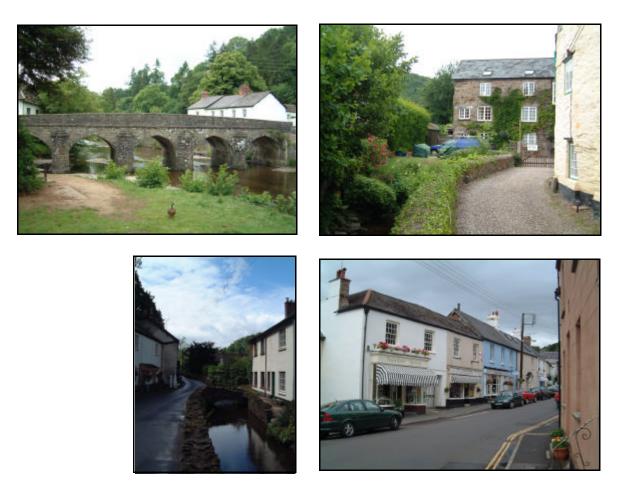
Aspects of townscape within the conservation area. <u>Top left</u>: Barle Bridge has medieval origins, but was widened in 1819 and rebuilt after flood damage in 1866 and 1952. <u>Top right</u>: Higher Mill, a former grist mill. The present building is probably mid 19th century. <u>Above left</u>: Northmoor with the mill leat, originally supplying water to several mills providing an attractive water feature. <u>Above right</u>: The lower part of High Street is one of two well enclosed spaces of good townscape quality and containing most commercial premises. <u>Below left</u>: the upper part of High Street is mainly residential with mixed frontages of 17th to early 20th century date. <u>Below centre</u>: Dulverton retains several narrow side streets; once a typical feature of towns in Devon and Somerset. <u>Below right</u>: a further example

7.4 **Barle Bridge**, built of local stone rubble with ashlar string course and coping, spans the river in five arches with pointed cutwater buttresses between a four-centre central arch. It is medieval in origin, but was repaired in 1624, and widened in 1819 by John Stone. It had to be repaired after flood damage in 1866 and 1952.

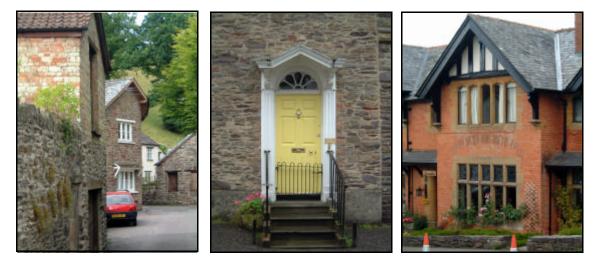
Dulverton retains a wide range of building styles and use of materials. <u>Left</u>: Town Marsh contains an informally arranged group of buildings of 18th –19th century origin, including a former chapel and smithy. <u>Centre</u>: a good example of a late 18th-early 19th century Georgian entrance in High Street. <u>Right</u>: built about a century later is an example of an Arts & Crafts style house, mainly using materials imported from elsewhere in Somerset or from South Wales.

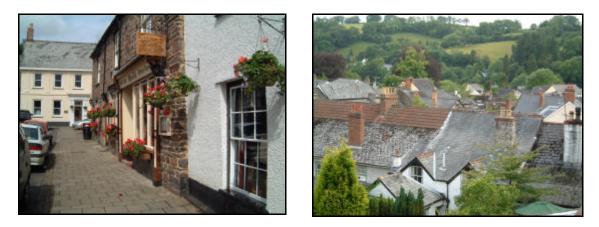
There is a mix of building materials and methods throughout the conservation area. <u>Left</u>: local stone is either left exposed or rendered using smooth (background) or roughcast render (foreground). <u>Right</u>: roofs are mainly of Welsh slate or varieties of clay pantile (e.g.double-Roman tiles), some replacing earlier thatch. Slate has in turn sometimes been re-

4.8 Originally, thatch would have been a more prevalent form of roofing material, but from the late 18th century slate was more commonly used. Welsh slate predominates, and a significant proportion has either been bitumenised or has been replaced by varieties of artificial slate. More recently, natural slate has started to be used again more widely, but most examples noted appeared to be of overseas origin. There was formerly a more local source of slate in heavier slabs, which originated mainly from the Brendon Hills, where a few slate quarries formerly flourished until the early 20th century, but no evidence of this roofing type was noted in Dulverton. The main alternative to slate is the red clay double-Roman tiles, most probably from the Bridgwater area. These have been used, either to replace thatch, or on buildings dating from the late 19th to early 20th century when the industry was at its height. Plain tiles also began to be used on new buildings from this time, but are less commonplace in Dulverton.

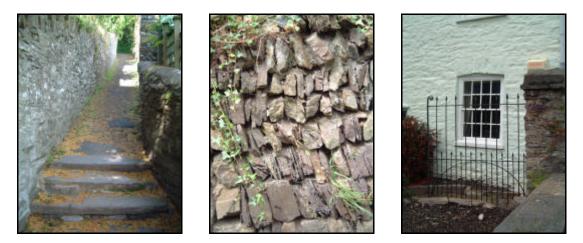
Other features also add to the quality of townscape. <u>Left</u>: one of several separate footpath routes within the conservation area, some of which date back several centuries. <u>Centre</u>: an example of the local type of dry stone walling. <u>Right</u>: historic metalwork, such as this wrought iron gate, are an important element of conservation area

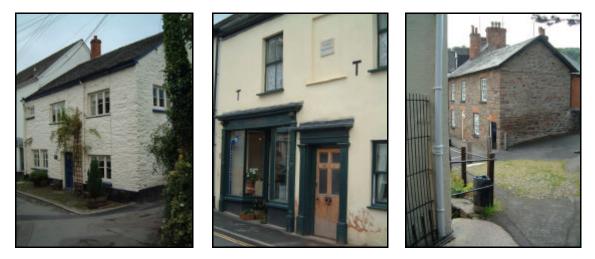
Dulverton has many buildings of character that are unlisted <u>Left</u>: house in Chapel Street with cobbled forecourt, probably dating from the 18th century. <u>Centre</u>: mid-late 19th century frontage, including an original shopfront in Fore Street. The plaque in the blind window indicates this was part of the site of the historic White Horse Inn.

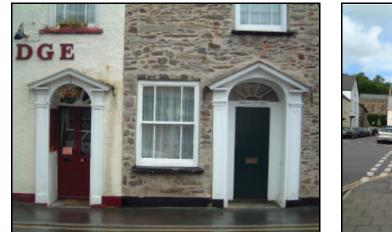
Further examples of unlisted buildings in the conservation area. <u>Top</u> <u>left</u>: early-mid 19th century frontage detail in Bridge Street <u>Top</u> <u>right</u>: Fore Street with 19th century shop front. <u>Above left</u>: doublefronted house, possibly originally early 19th century, but refronted with porch added in the late 19th-early 20th century. <u>Above right</u>: early 20th century workshop/stables of brick and tile, recently restored to original condition. <u>Right</u>: former chapel with hall adjoining dating from 1902, restored as private dwellings. <u>Below left</u>: detail of Arts & Crafts house in High Street c.1900 <u>Below right</u>: another example of Arts & Crafts detail probably early

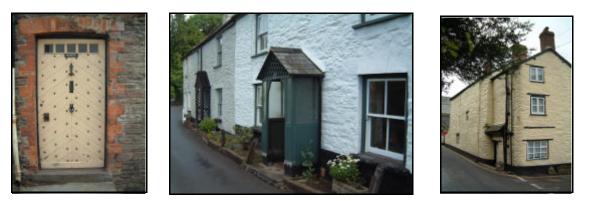
<u>Left</u>: Arts & Crafts entrance door in Jury Road of c.1900. <u>Centre</u>: frontage detail at Northmoor, probably dating from the late 19th century. <u>Right</u>: this three-storey building at the northern end of Lady Street is recorded by various

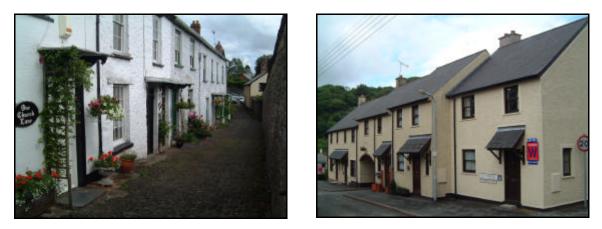
<u>Left</u>: frontage detail in Church Terrace; all the buildings shown are grade II listed. <u>Right</u>: new housing within the conservation area reflects the local scale, although the dark-stained timber is not traditional, and little opportunity is pro-

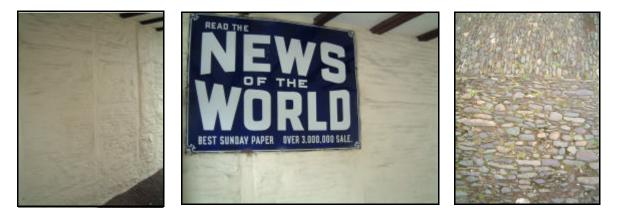
<u>Left</u>: the painted wall of an alleyway off High Street displays some evidence of timber-framing. <u>Centre</u>: historic signs, in this case of enamel, add visual interest regardless of content. <u>Right</u>: cobbled surfaces using natural materials add pat-

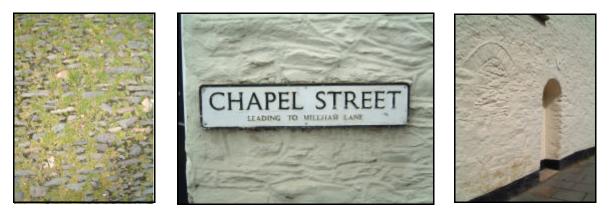
Further examples of surface textures and signage. <u>Left</u>: a cobbled surface at the top of Fore Street near the Lych gate. The restoration of such historic surfaces, including the possible uncovering of similar cobbled areas subsequently covered in asphalt could form part of a wider enhancement project. <u>Centre</u>: a cast iron street nameplate. There are a number of signs of this type in Dulverton worthy of retention. <u>Right</u>: not all buildings have been adequately researched to determine their date and original function. This wall of the Guildhall Centre containing a blocked arch and round-headed

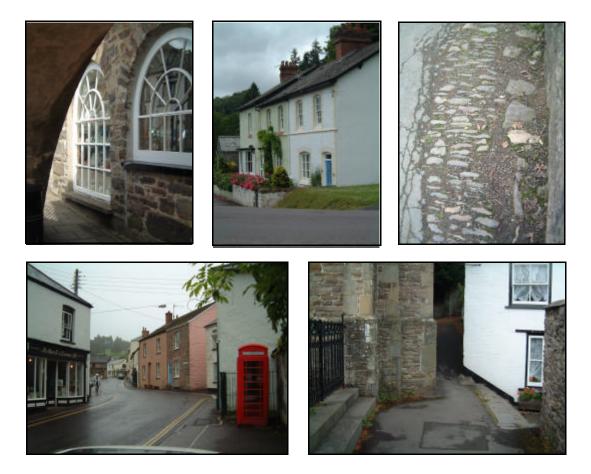
<u>Top left</u>: window detail at Market Hall. Such buildings could be highlighted as part of a town trail. <u>Top centre</u>: a cottage row to the west of the River Barle which has a strong visual link to the present conservation area and could be included in any future extension. <u>Top right</u>: another example, in this case in Chapel Street of a section of cobbled pavement that could be restored. <u>Above left</u>: the high quality of townscape in Dulverton derives from the visual interest created by an intricate scale, alignment and juxtaposition of buildings of a rich variety often seen against a wooded backdrop. Removal of overhead lines would be a further advantage. <u>Above</u> <u>right</u>: some parts of the village are only accessible on foot, but provide a quiet setting away from traffic.
